**RE: Next Media Operating, Inc. - Update  
114 Tower Hill Road  
Gilberts, Illinois**

URS Corporation (URS) respectfully submits the following update regarding the ongoing remediation of lead-impacted soils at 114 Tower Hill Road (the Site) located in Gilberts, Illinois. URS performed the scope of work described below in accordance with the work plan (WP) approved by the United States Environmental Protection Agency (USEPA), dated December 2004, and subsequent WP amendment, dated October 6, 2005. For your convenience, URS has included photographs taken during field activities and a sample location map, which are referenced below.

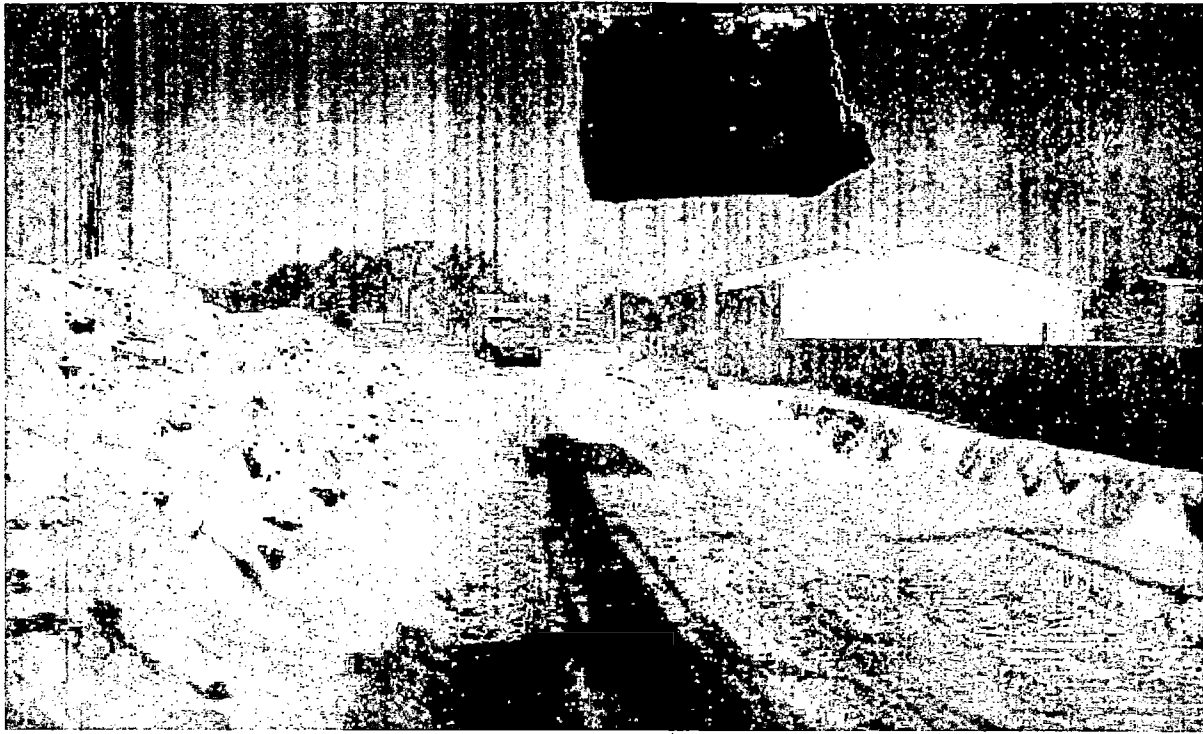
Photo 1 – General view of impacted area located southwest of Village of Gilberts Public Works garage (facing north).

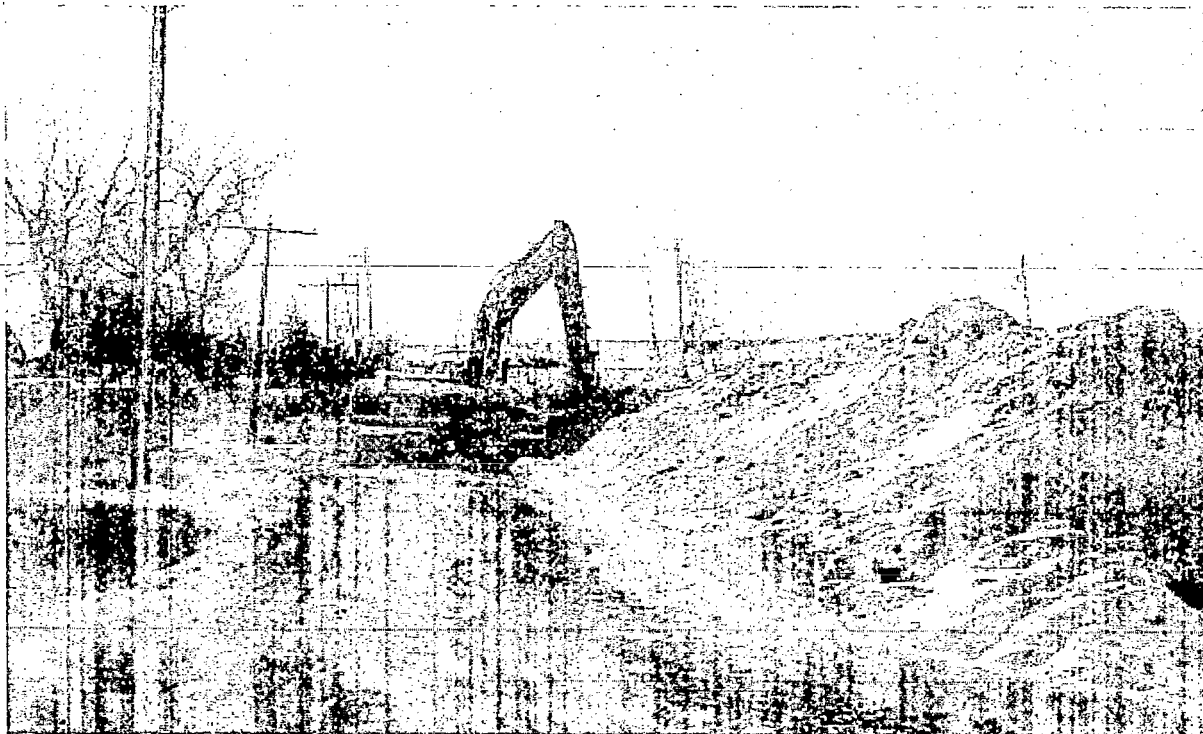
Photo 2 – General view of impacted area located southwest of Village of Gilberts Public Works garage (facing north).
